InSpec Home Inspection

SUMMARY REPORT

Client: Chris Zavarella
Realtor: Chris Zavarella, Realty USA Southwest
Inspection Address: 8301 N 97th Dr, Peoria, AZ
Inspection Date: 10/21/2005
Inspected by: Kelly D. Lopez - AZ Cert 39582

CONFIDENTIAL INSPECTION REPORT

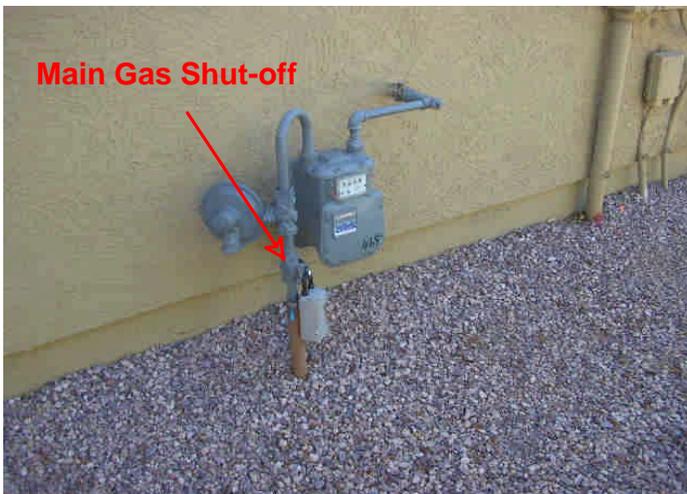
5.5 - The gas main shut-off is located in the garage side yard . You should be aware that gas leaks are not uncommon, particularly underground leaks, and that they can be difficult to detect without the use of sophisticated instruments, which is why natural gas is odorized in the manufacturing process. Therefore, we recommend that you request a recent gas bill from the sellers, so that you can establish a norm and thereby be alerted to any potential leak.

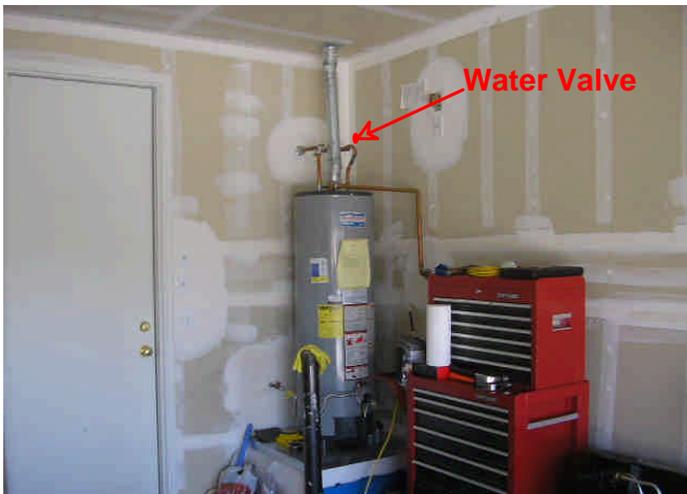
5.9 - The shut-off valve and water connectors are functional. However, they are not in daily use and will inevitably become stiff or frozen.

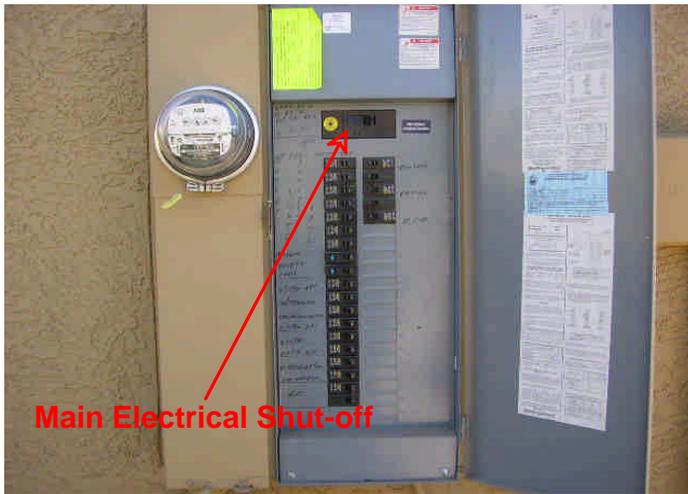
6.2 - The residence is served by a 200 amp, 220 volt panel, located at the garage side yard. Service conductors are copper in acceptable condition.
